Marine Accident Report

Fire On Board the Small Passenger Vessel *Port Imperial Manhattan*, Hudson River New York City, New York November 17, 2000

**National
Transportation
Safety Board**
Washington, D.C.

**NTSB/MAR-02/02
PB2002-916402
Notation 7472
Adopted June 11, 2002**

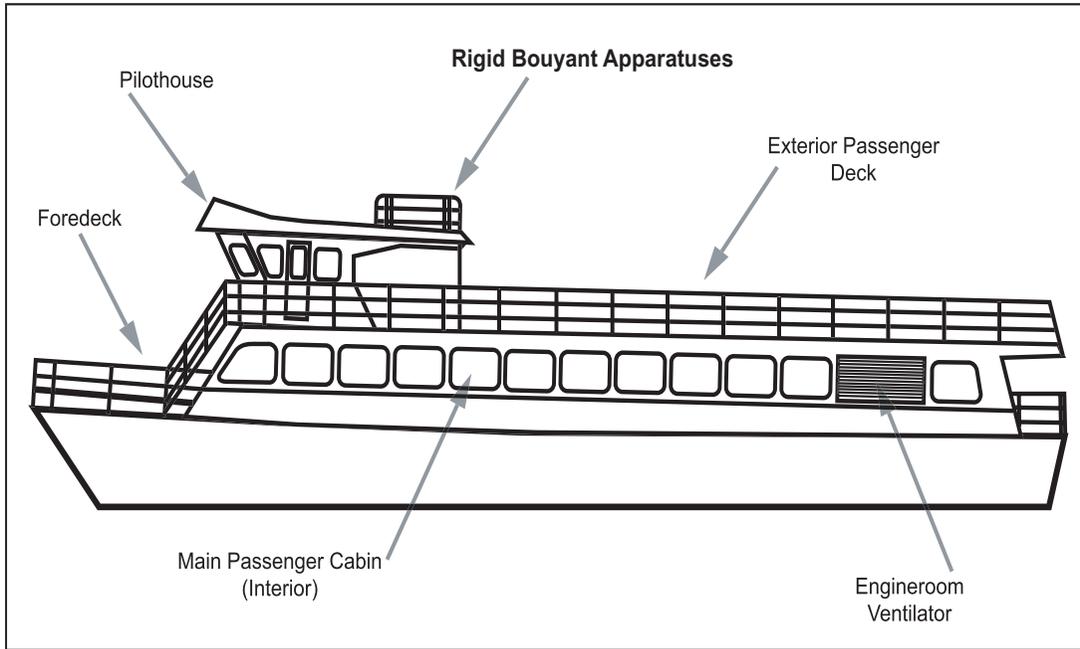
After leaving the dock, the master decided to have dinner and turned over the conn to deckhand No. 1. The master remained in the pilothouse to eat and was facing aft when he observed smoke coming from the port ventilator to the engine space. (See figure 2a.) About the same time, deckhand No. 1 told the master that the throttle felt as if it was not responding. The master sent the deckhand to the engine space to investigate and radioed another NY Waterway ferry to stand by until the cause of the smoke could be identified. Immediately following this radio transmission, the *Port Imperial Manhattan* lost propulsive power and steering control, and the vessel's VHF radio lost power.

Figure 2a. The master was looking aft from the pilothouse when he saw smoke issuing from the engineroom ventilator on the port side of the vessel.

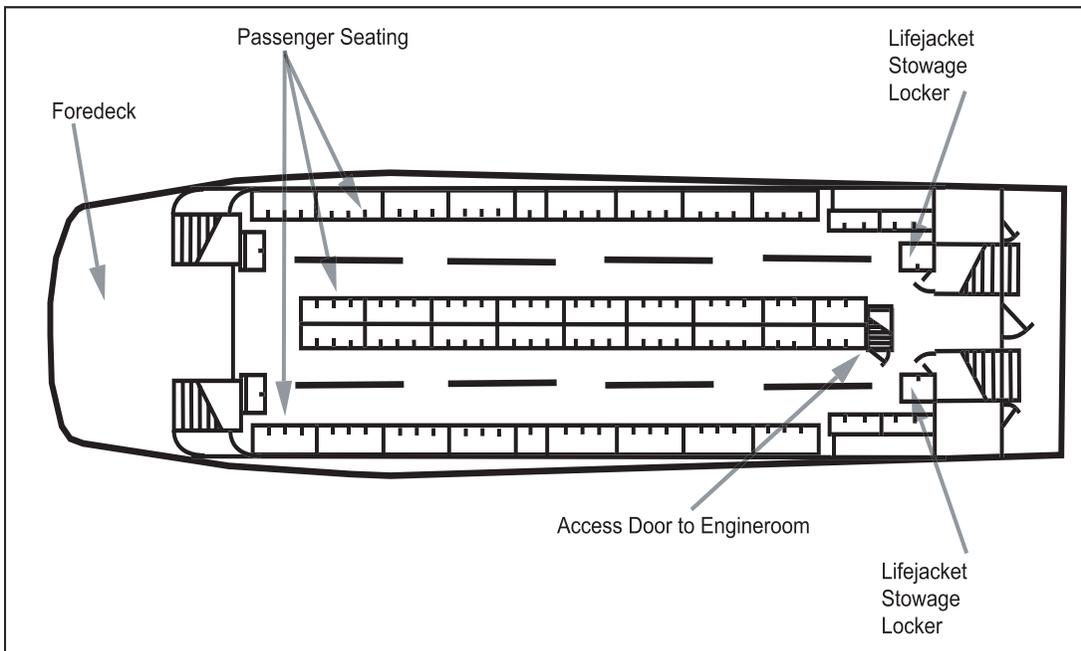
The deckhands proceeded to the engineroom entry door located aft in the main passenger cabin. (See figure 2b.) The deckhands stated that they opened the aluminum door without first using their hands to feel for heat inside the space.⁴ Both deckhands stated that they received an electrical shock while holding the door open and were unable to enter the space because heavy smoke filled the engine compartment. They observed flames between the rungs of the ladder leading down into the engineroom. The deckhands said that they did not immediately inform the master about the fire. Rather, they decided to try and extinguish the fire. They propped open the access door with two lifejackets. Deckhand No. 1 said that he retrieved a CO₂ fire extinguisher that was stowed on the stern and discharged its contents into the engineroom compartment.

Figure 2b. At the master's direction, the deckhands went to check the engineroom, which was accessed through a door in the after area of the main passenger cabin.

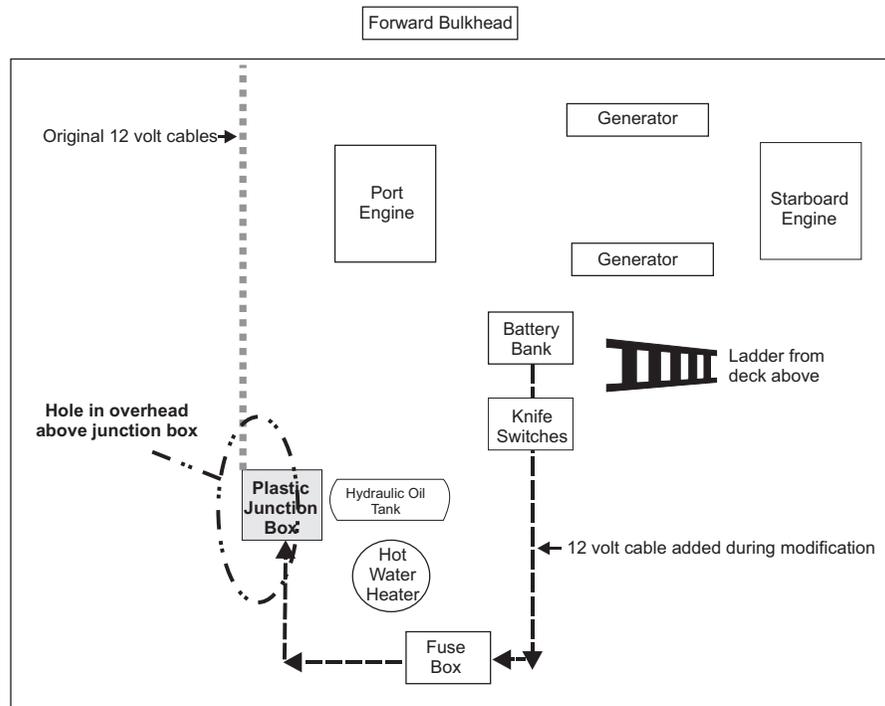
The access ladder to the engineroom, located near the aft end of the main passenger cabin, stepped down in an athwartships, or side-to-side, direction. (See figure 3.) A hydraulic oil tank that provided fluid for the steering system was next to the hull, on the port side of the ladder. The port and starboard engines were near the forward engineroom bulkhead, and the generator was next to the forward bulkhead. Air was supplied to the engineroom through two vents located on the open upper deck. Each vent had a hinged damper.

Figure 3. In 1992, the electrical system was modified and the battery backup was relocated from the forward bulkhead to beneath the access ladder. New wiring extending from the batteries was joined to the previous wiring in a plastic junction box on the port bulkhead. During postaccident examination, investigators observed a hole in the overhead, above the junction box.

From interviews with company personnel, investigators determined that, during a 1992 modification of the electrical system, a 32-volt DC main engine starting system had been removed from its original position at the forward bulkhead of the engineroom and had been replaced with two 12-volt batteries that were installed at the aft end of the engineroom, beneath the access ladder. As installed, the 12-volt batteries had been beyond the reach of the existing wiring for the starting system. To bridge the gap between the existing wiring and the batteries, No. 2 AWG copper wires had been run from the old battery bank location to the new position. Two lug bolts had connected the new and old wires, and the connections had been enclosed in a plastic junction box, which had been installed over the hydraulic oil tank in the port aft corner of the engineroom.

Investigators could not locate the plastic junction box, which was probably destroyed in the fire. They did find the lug nut connection holding the old and new wires; however, the wires on either side of the lug nuts had burned through. Much of the wire’s insulation had been burned off, with most of the damage closest to the point where the old and new wires were connected. The lug nuts connecting the wires were loose. The 12-volt DC cables matching other sections of the electrical system had sustained heavy damage. The cables showed evidence of beading, which indicates a high temperature condition.

High resistance connections can be caused by a poor splice, loose or intermittent connections, or by corroded connections. After the fire, investigators found loose wire connectors on the wire ends where the old and new wires were joined during the 1992 system modifications. The probability is high that, if the connections were left unchecked over an 8-year period, vibration and thermal cycling caused them to loosen. A loose connection would increase electrical resistance in the circuit, causing the wire at the connection to overheat, which, in turn, could result in the insulation igniting.

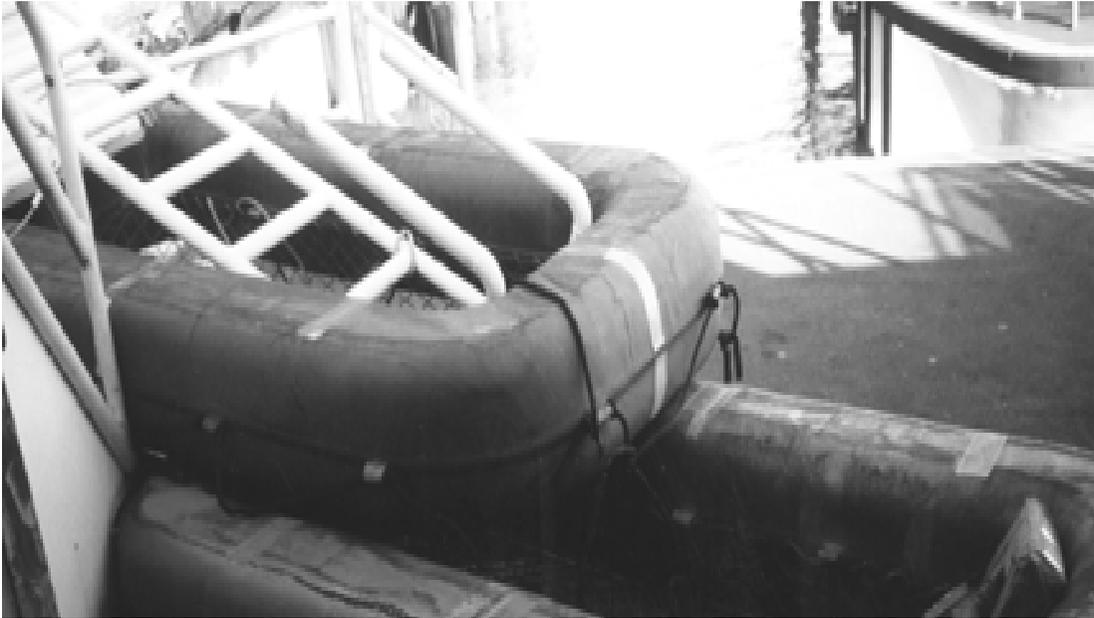
Figure 4. Postaccident view of two RBAs retrieved by crewmembers on board the *Port Imperial Manhattan*. An RBA lacks a platform to carry survivors. The ring-shaped flotation device is surrounded by a line that survivors in the water can grasp until they are rescued. On the night of the *Port Imperial Manhattan* fire, the lines of the vessel's RBAs became tangled, and crewmembers cut some of them to free the devices.
